GEOTECHNICAL REPORT

March 29, 2002
J.N. 147-95

Subject: Update of Geologic Reconnaissance and Environmental Impact Assessment Report of Lawrence Property, 19191 Lawrence Canyon Road, County of Orange, California.

**GEOTECHNICAL INVESTIGATION, PROPOSED
BUILDING A-D, COVERED BRIDGE, ENTRANCE
GATE, AND EXISTING BUILDING "E", RANCHO
LAS LOMAS, 19191 LAWRENCE CANYON ROAD,
COUNTY OF ORANGE, CALIFORNIA**

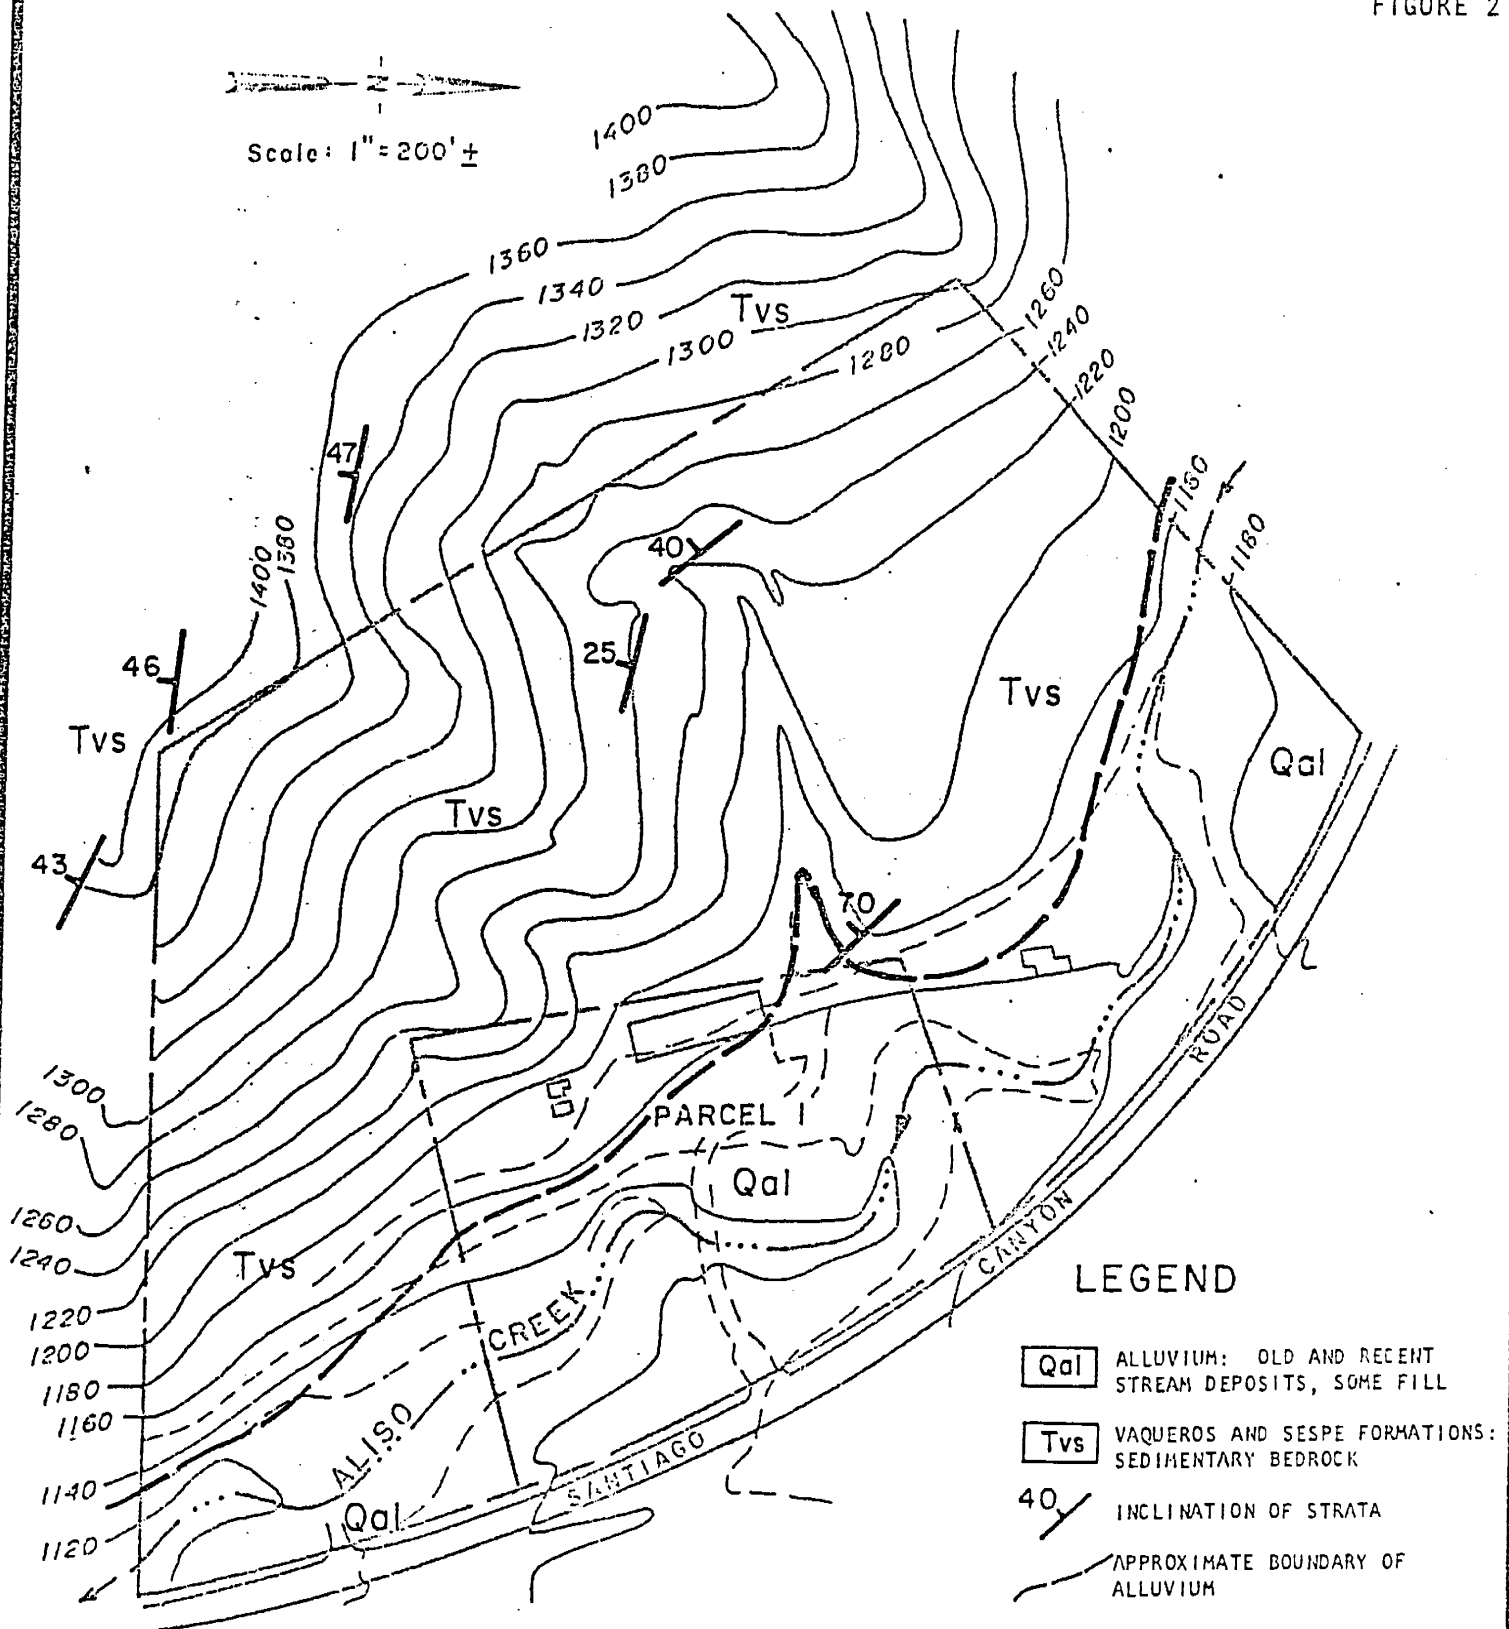
FIGURE 2

GEOLOGIC MAP
LAWRENCE PROPERTY
SANTIAGO CANYON ROAD, ORANGE COUNTY

Existing slope stability conditions within the site are generally favorable, as evidenced by the absence of significant landslides. The on-site bedrock formation, however, is susceptible to erosion and relatively shallow, slump-type failures which typically affect the near-surface soils or weathered bedrock materials, particularly where they underlie the steeper slopes in the westerly portion of the site (refer to Figure 2). Erosion can occur along existing drainage channels and unpaved access roads, particularly from heavy runoff during the rainy season.

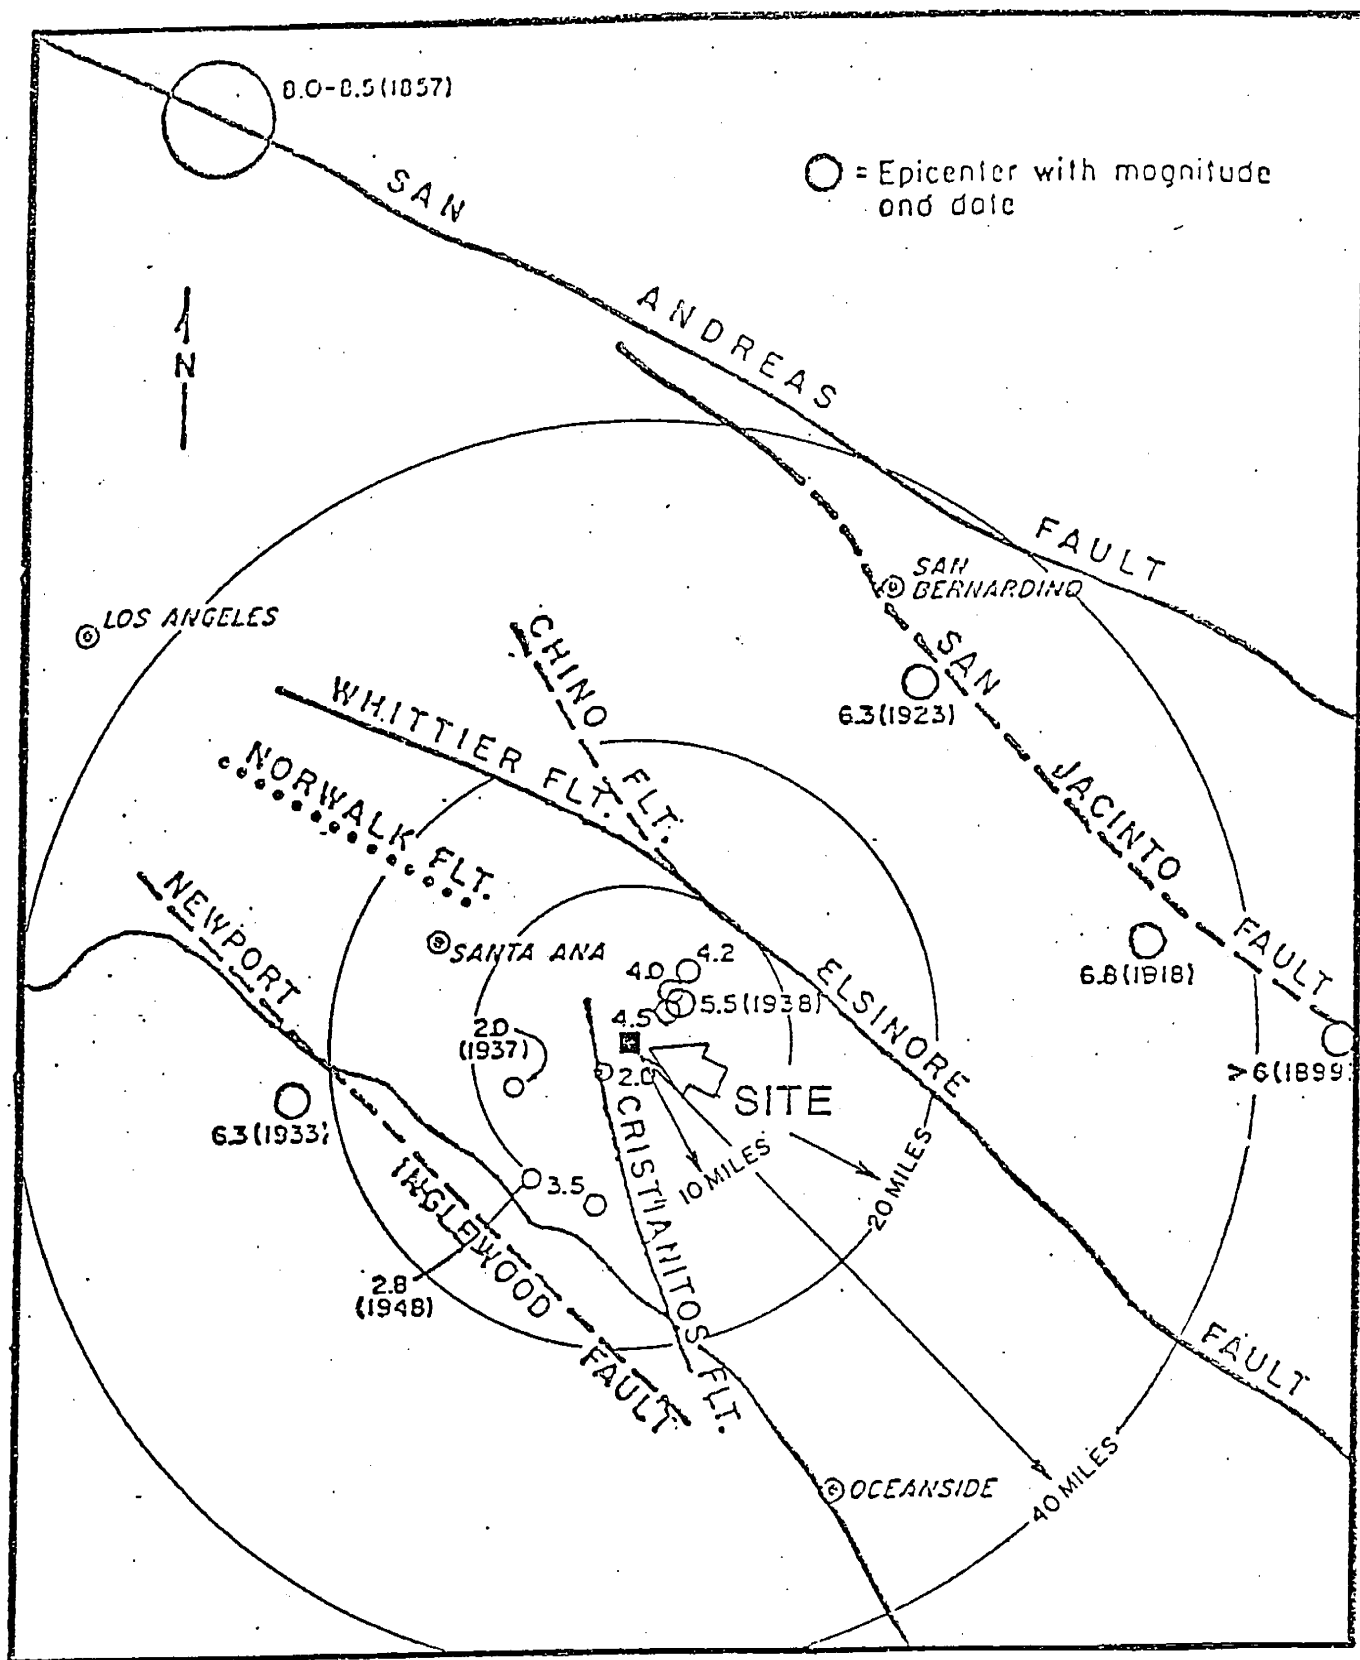
MAP OF FAULTS AND REGIONAL SEISMICITY
OF

The nearest major faults are approximately 800, 4,500 and 5,500 feet west of the site. The latter two are probable extensions of the Cristianitos fault zone and may be considered potentially active, based on data further south, along the zone (refer to Figure 3). In the absence of known active faults in the vicinity, however, there have been no Alquist-Priolo Special Studies Zones established on or near the site. Therefore, no mandatory requirement for the special investigation of fault rupture hazards imposed by such zones applies to the subject property.

In the absence of any major faults crossing the site, the hazard of ground rupture from fault displacement is considered to be nil. Therefore, no special fault studies or construction limitations due to fault movement potential apply to the subject site. Subsequent geologic site investigations and inspections required by the County at various development stages should provide appropriate mitigation measures if a major fault is found within the site.

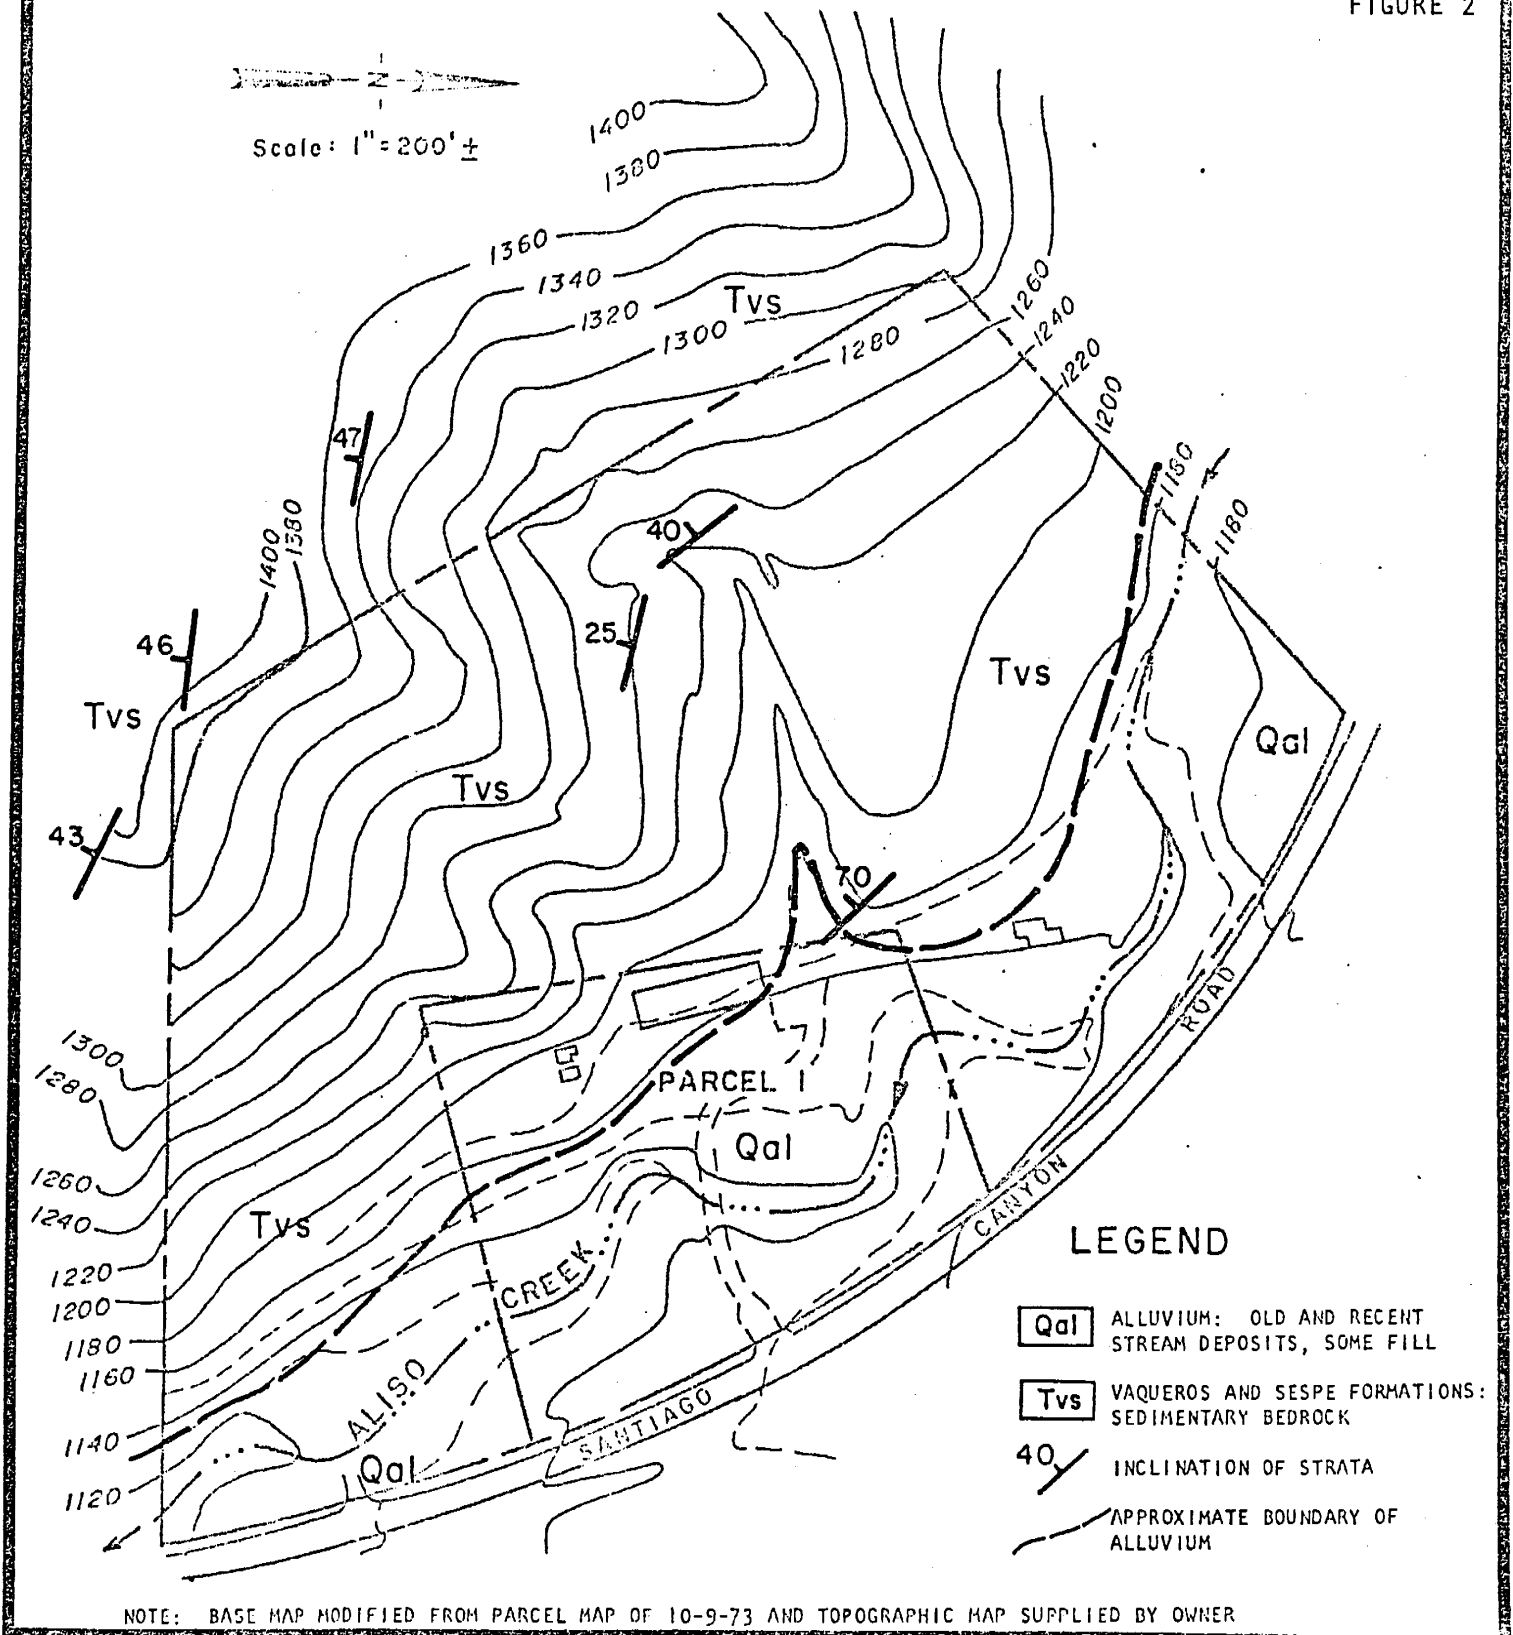
FIGURE 2

GEOLOGIC MAP
LAWRENCE PROPERTY
SANTIAGO CANYON ROAD, ORANGE COUNTY

An earlier published map (Reference 9) indicated the possible existence of a large landslide underlying the more gently sloping knoll in the north portion of the site. Subsequent mapping by the state (Reference 8) and by us during our recent reconnaissance revealed no supportive evidence that a slide is present.

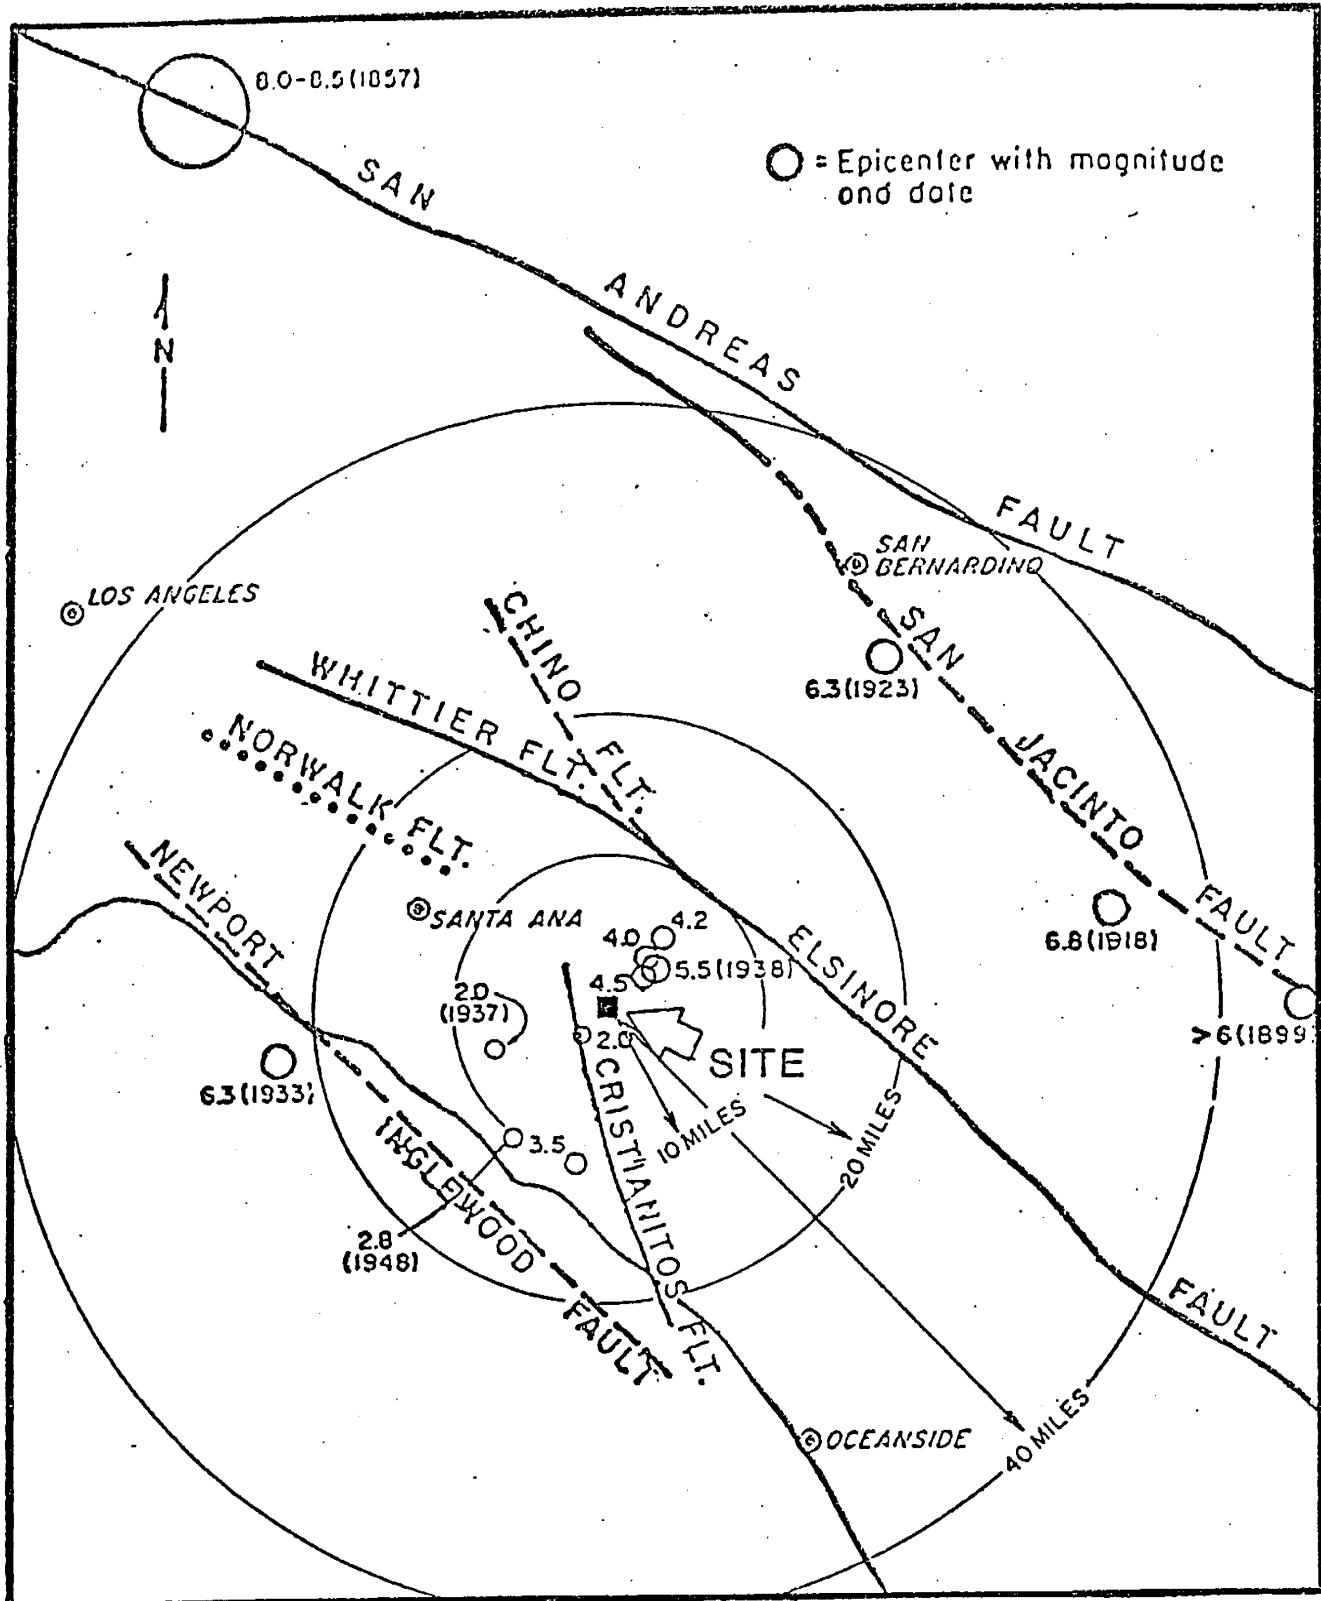
MAP OF FAULTS AND REGIONAL SEISMICITY
OF

LAWRENCE PROPERTY
(FROM MORTON AND OTHERS, 1974)
